GBG Australia

BRIDGE INVESTIGATIONS

Non Destructive Techniques for BRIDGE INVESTIGATIONS

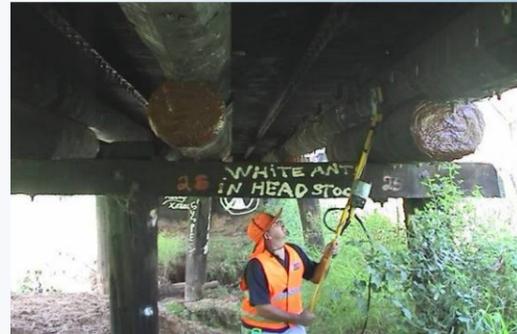
Radar profiling timber girders at Redbank bridge QLD.

Redbank & Purga Creek Bridges, Validation investigation of NDT methods for timber bridge investigations. (2002)
